Brief Report on “So Bhir” Landslide on 13/08/2016 near the Mantam village, North Sikkim - Analysis using Cartosat-2B image

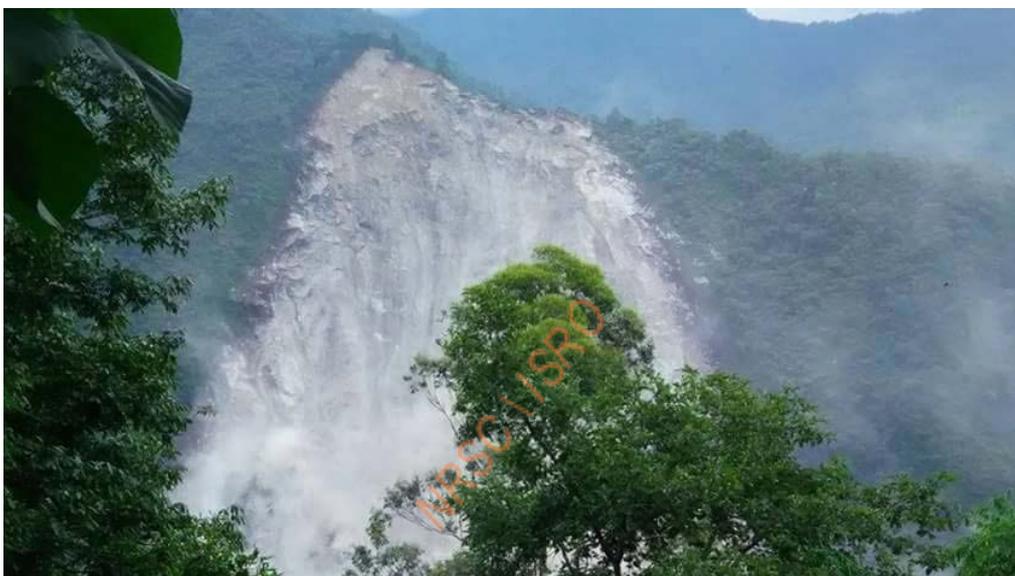
Figure 1: Photograph of the Mantam landslide (Source: Social media).

A massive landslide occurred near the village of Mantam (opposite to the Passingdang-Mantam Road) in Sikkim at around 13:30 hrs (IST) on 13th of August, 2016 (Figure 1). As per the news reports formation of the lake and consequent rise in water level submerged the Kanka bridge and washed away about 300 metres of road. Five houses in the Mantam village have been submerged. The villages of Tingvong, Lingdem, Laven , Kayeem, Lingzya , Bay , Sakyong Pentong and Ruklu Kayeem are cut-off due to the damage to the connecting road. There are no human casualties reported from the incident.

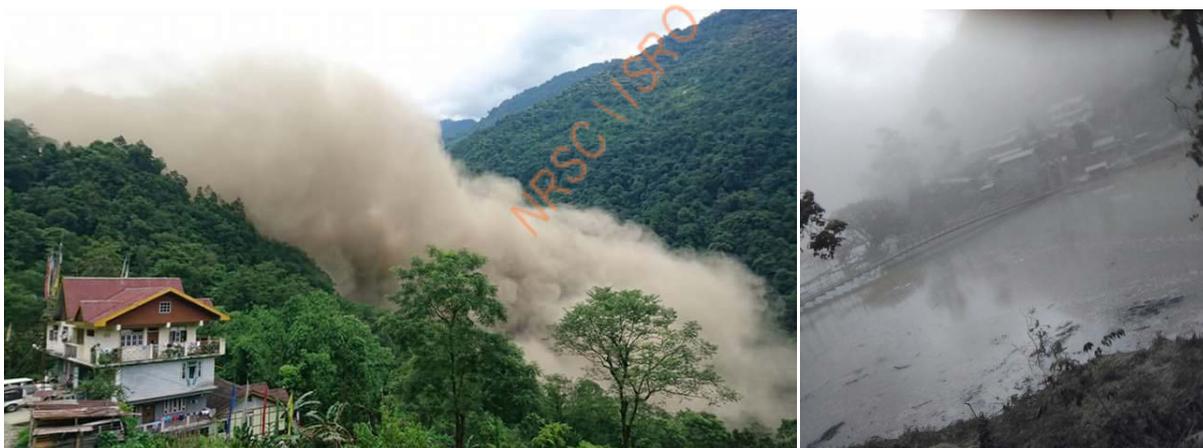
Figure 2a: Dust cloud from the landslide; 2b: Artificial lake formation due to the landslide (Source: Social media)

The landslide generated a huge cloud of dust engulfing the nearby settlements (Figure 2a). From the field photograph it appears that it is a rock avalanche and the dust cloud was formed due to rapid downslope movement of dry rockmass resulting in airblast. The debris from the landslide is believed to have blocked the flow of the Kanaka river/Ringpai Chu, which is one of the main tributaries to the Teesta River.

An analysis was carried using very high resolution Cartosat-2B (80 cm) image acquired on 15 August 2016. The water impoundment has resulted in the formation of artificial lake of 2.2 km length and 209 m width at the lake head, north of the Mantam (Figure 2b). The width of the landslide is 530 m in the middle and length is 790 m. The landslide is rectangular in shape. The crown of the landslide is on the ridge line (Figure 3). Debris deposits are clearly observed on either side of the ridge line. Joints exposed after the landsliding suggest a wedge type failure near the crown of the landslide followed by translational type of failure in the main body of the landslide.

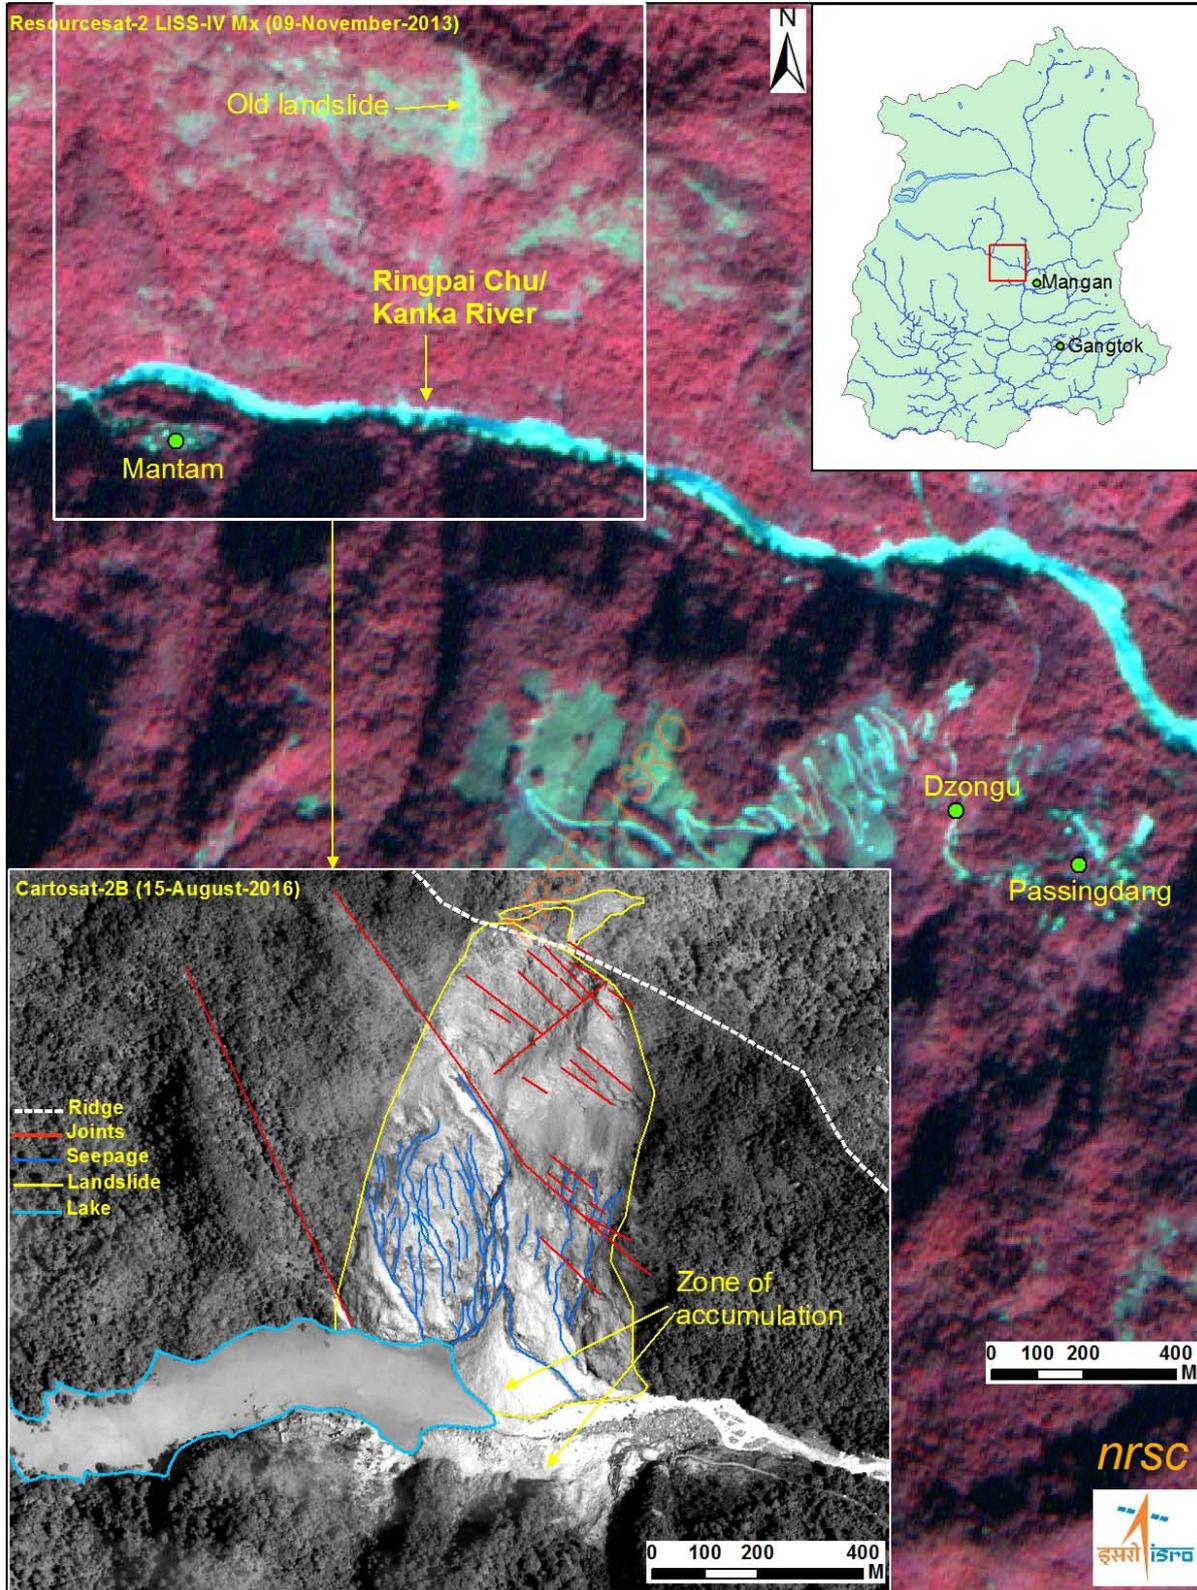
Landslide on 13-08-2016 near Mantam village in North Sikkim

Figure 3. Analysis of Mantam landslide using Cartosat-2B image.

This area is near to Main Central Thrust (MCT), which takes a convex turn to the north and also has a tectonic window known as Rangit window. Due to the presence of MCT, high grade central Himalayan crystalline rocks (e.g. quartzites and granite gneisses) exposed in this area were subjected to shearing which is evident from the density of joints in the landslide scarp region. Area around Sakkyong in the upstream part of the Kanka river also witnessed severe landslide occurrences during the Sikkim earthquake on 18 September 2011. Groundwater seepages from the exposed joint planes are clearly visible in the Cartosat-2B image. Therefore, the role of aquifer induced pore pressure (due to earlier monsoon rains) and escarpment stress condition as evident from the presence of an old landslide could be probable causative factors for the landslide occurrence on 13 August 2016.

The water impoundment may have presented a serious threat to settlements downstream and installations like the Teesta Low Dam Project V of NHPC. However, as seen from the Cartosat 2B image, the river water has overtopped the debris dam and now flowing along its natural course in the form of a turbulent rapid, without any lateral breaching. As a consequence of this, the lake is draining out through the narrow outlet and there is no eminent water level rise. Nevertheless, it is important to monitor the water spread and the volume of the lake over the next few weeks, as a sudden even of high rainfall in the upstream areas, can lead to rapid water level rise and submergence of the habitations beside the lake.
